**Flood Control Project Maintenance
Levee Inspections**

Fall 2013 Levee Maintenance Deficiency Summary Report

Reclamation District No. 0765 Glide

Waterway	Bank	Unit Miles
Unit No. 01 Sacramento River	Right	1.74

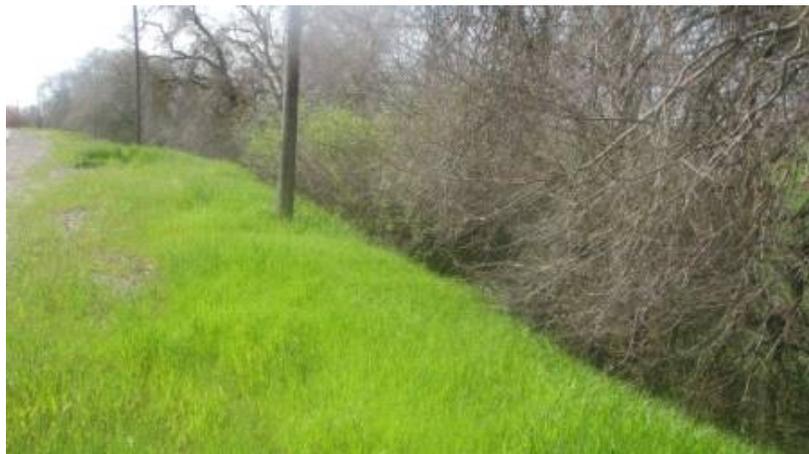
Levee Mile Report Line	7
Start Levee Mile	0.12
End Levee Mile	0.19
Location	Land Side
Category	Earthen Levee
Item	Trim / Thin Trees
Looking downstream (south) at trees on landside slope & toe.	
richard_f_20130930_756.jpg

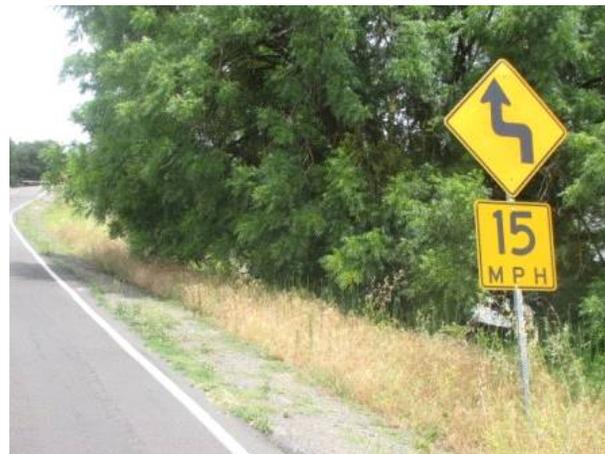
Levee Mile Report Line	13
Start Levee Mile	0.25
End Levee Mile	0.28
Location	Water Side
Category	Earthen Levee
Item	Trim / Thin Trees
Looking northeast at overgrown trees on waterside slope.	
richard_f_20130930_741.jpg

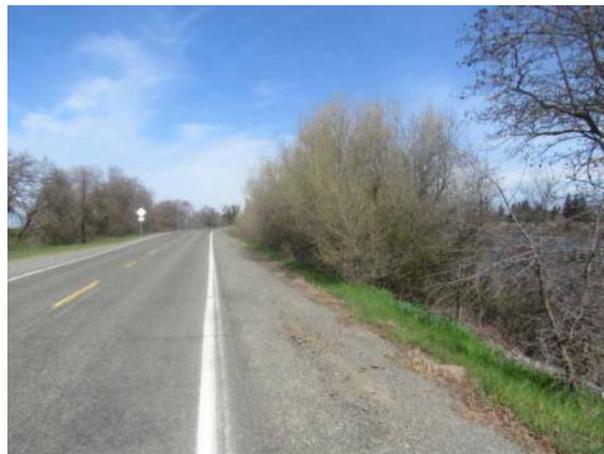
Levee Mile Report Line	13
Start Levee Mile	0.25
End Levee Mile	0.28
Location	Water Side
Category	Earthen Levee
Item	Trim / Thin Trees
Looking north (upstream) at dense trees on landside slope and shoulder. (Spring 2013)	
richard_f_20130930_744.JPG

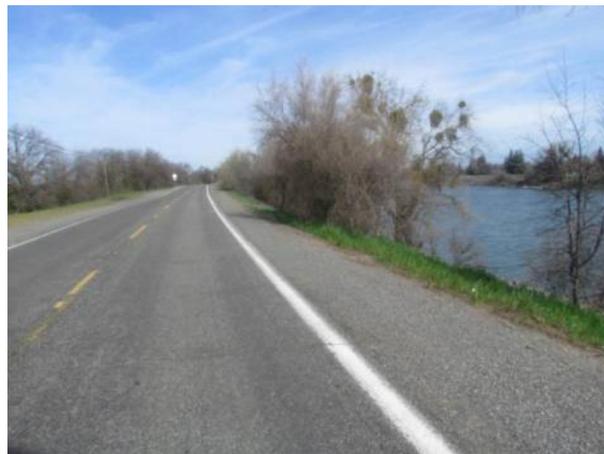
Levee Mile Report Line	16
Start Levee Mile	0.32
End Levee Mile	0.32
Location	Water Side
Category	Earthen Levee
Item	Trim / Thin Trees
Looking north (upstream) at untrimmed trees on waterside shoulder and slope.	
richard_f_20130930_754.JPG

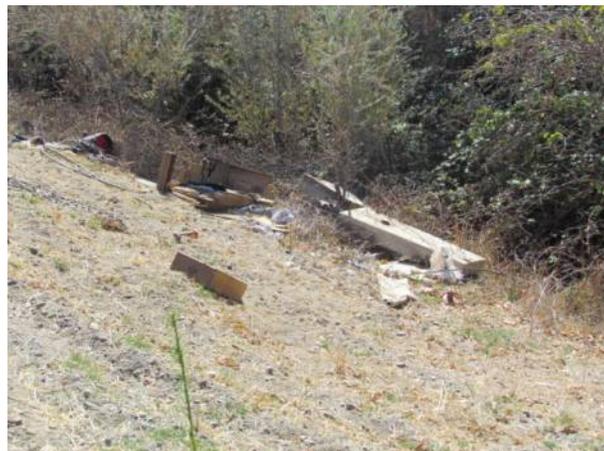
Levee Mile Report Line	21
Start Levee Mile	0.47
End Levee Mile	0.47
Location	Land Side
Category	Earthen Levee
Item	Encroachments
Looking west at garbage on landward slope and toe.	
richard_f_20131024_122.JPG

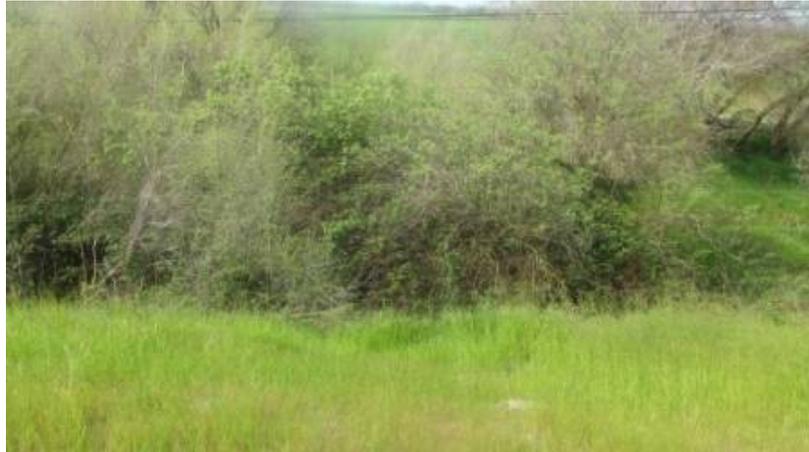
Levee Mile Report Line	22
Start Levee Mile	0.48
End Levee Mile	0.50
Location	Land Side
Category	Earthen Levee
Item	Vegetation

Looking northwest at trees on landside toe from 2010 fall inspection.

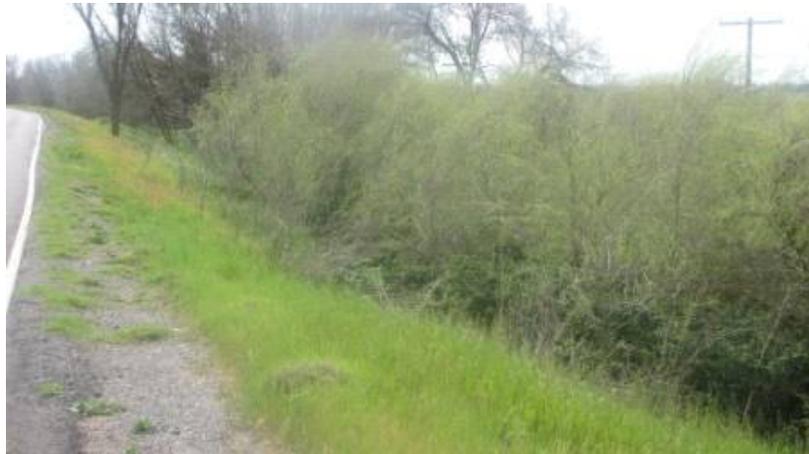
Levee Mile Report Line	22
Start Levee Mile	0.48
End Levee Mile	0.50
Location	Land Side
Category	Earthen Levee
Item	Vegetation

Looking downstream (south) at trees on landside slope & toe.

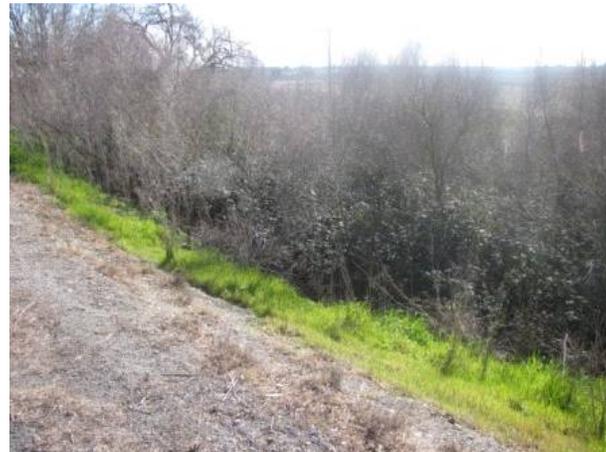
Levee Mile Report Line	22
Start Levee Mile	0.48
End Levee Mile	0.50
Location	Land Side
Category	Earthen Levee
Item	Vegetation

Looking downstream (southwest) at dense vegetation on landside slope.

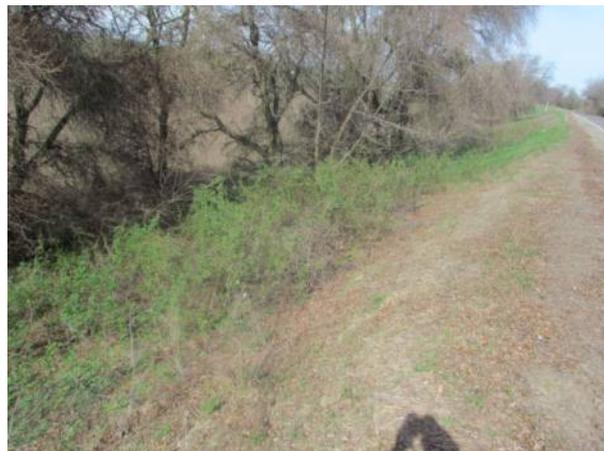
Levee Mile Report Line	28
Start Levee Mile	0.76
End Levee Mile	0.80
Location	Land Side
Category	Earthen Levee
Item	Vegetation
Looking northwest at vegetation on landside slope.	
richard_f_20130930_776.JPG

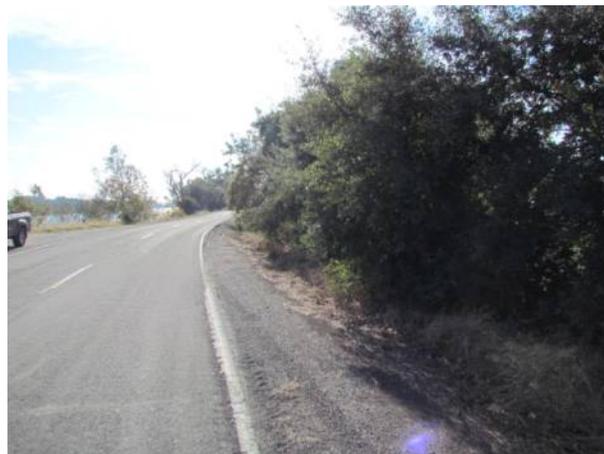
Levee Mile Report Line	30
Start Levee Mile	0.87
End Levee Mile	0.99
Location	Land Side
Category	Earthen Levee
Item	Trim / Thin Trees
Looking south at dense trees on landside shoulder and slope. (November 2011)	
richard_f_20130930_750.jpg

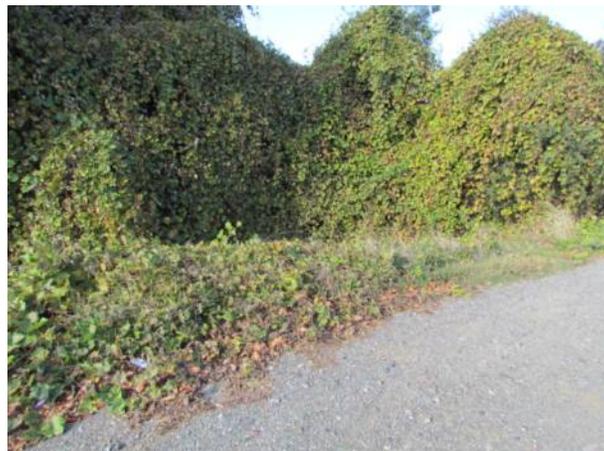
Levee Mile Report Line	31
Start Levee Mile	0.97
End Levee Mile	0.97
Location	Land Side
Category	Earthen Levee
Item	Vegetation
Looking west at dense berryvines and wildroses on landside shoulder and slope. (November 2011)	
richard_f_20130930_779.jpg

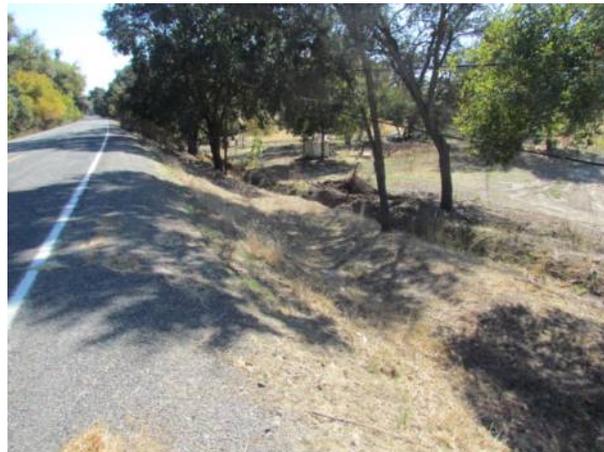
Levee Mile Report Line	32
Start Levee Mile	0.99
End Levee Mile	0.99
Location	Land Side
Category	Earthen Levee
Item	Encroachments
Looking southwest at irrigation ditch on landward toe.	
richard_f_20131024_119.JPG

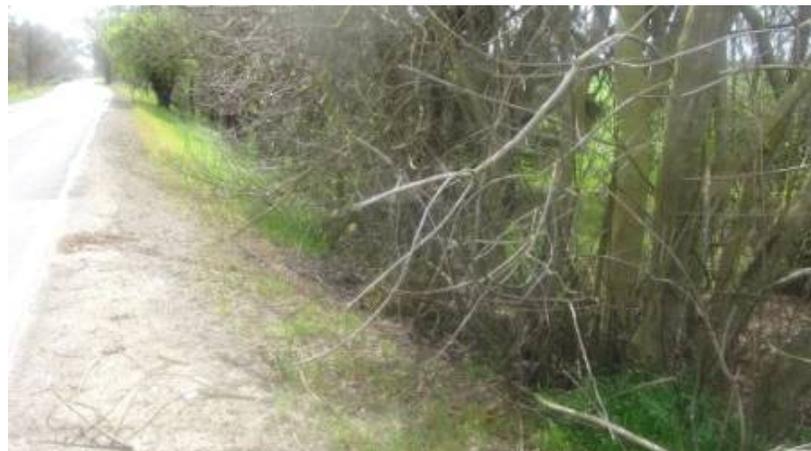
Levee Mile Report Line	36
Start Levee Mile	1.08
End Levee Mile	1.08
Location	Land Side
Category	Earthen Levee
Item	Trim / Thin Trees
Looking downstream (south) at trees on landside slope & toe from 2010 fall inspection.	
richard_f_20130930_768.jpg

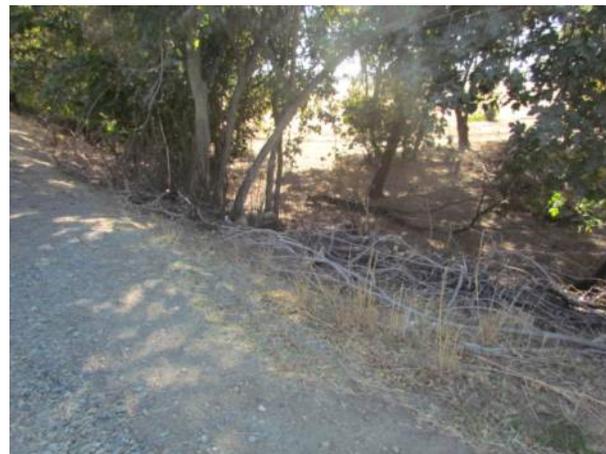
Levee Mile Report Line	36
Start Levee Mile	1.08
End Levee Mile	1.08
Location	Land Side
Category	Earthen Levee
Item	Trim / Thin Trees
Looking southwest at trees on landward slope.	
richard_f_20131024_120.JPG

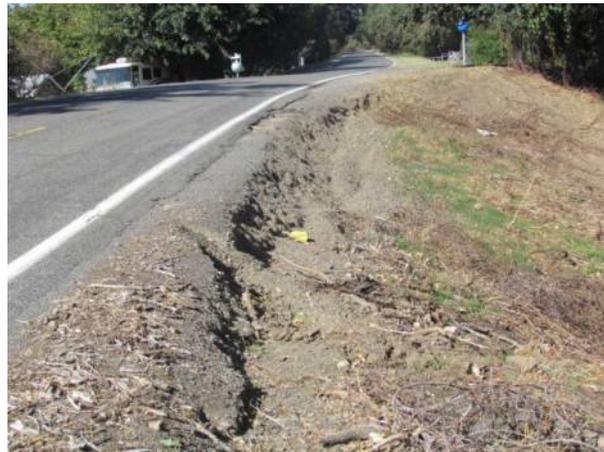
Levee Mile Report Line	41
Start Levee Mile	1.32
End Levee Mile	1.34
Location	Water Side
Category	Earthen Levee
Item	Slope Stability
Looking north at slope damage on waterward shoulder.	
richard_f_20131024_114.JPG

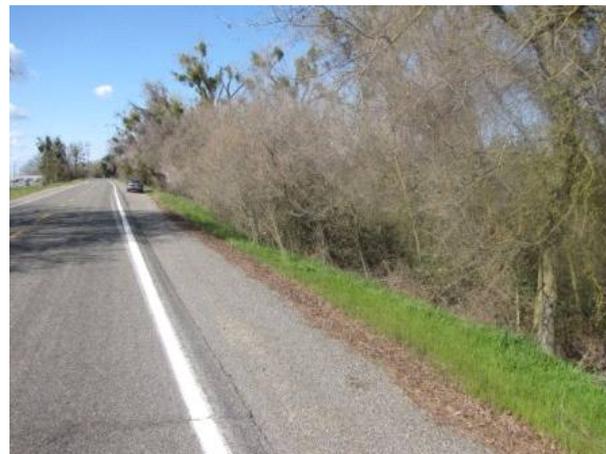
Levee Mile Report Line	47
Start Levee Mile	1.44
End Levee Mile	1.47
Location	Water Side
Category	Earthen Levee
Item	Trim / Thin Trees
Looking upstream (north) at dense trees on waterside slope.	
richard_f_20130930_737.jpg

DWR ID: DWR_RD0765_01_f_2013_57										
47	1.44	1.47	Earthen Levee	Trim / Thin Trees	WS Ma	M	T2 : Thin trees to allow visibility of the ground and room to flood fight.	38.483925 ° -121.551845 °	38.483530 ° -121.551587 °	5 Y
DWR ID: DWR_RD0765_01_s_2012_5										
48	1.46	1.46	Earthen Levee	Trim / Thin Trees	LS A/W Ma	M	T1 : Trim trees to at least five feet above ground level.	38.483640 ° -121.551727 °	38.483640 ° -121.551727 °	41
DWR ID: DWR_RD0765_01_s_2012_41										
49	1.48	1.48	Earthen Levee	Slope Stability	LS Ma	M	S3 : Repair the levee slope damaged by vehicle traffic and prevent access where possible. Inspector Comments: Slope damage on landward slope.	38.483379 ° -121.551545 °	38.483379 ° -121.551545 °	58 Y
DWR ID: DWR_RD0765_01_f_2013_58										
50	1.48	1.48	Earthen Levee	Slope Stability	WS Ma	M	S3 : Repair the levee slope damaged by vehicle traffic and prevent access where possible. Inspector Comments: Slope damage caused by tractor.	38.483353 ° -121.551457 °	38.483353 ° -121.551457 °	19 Y

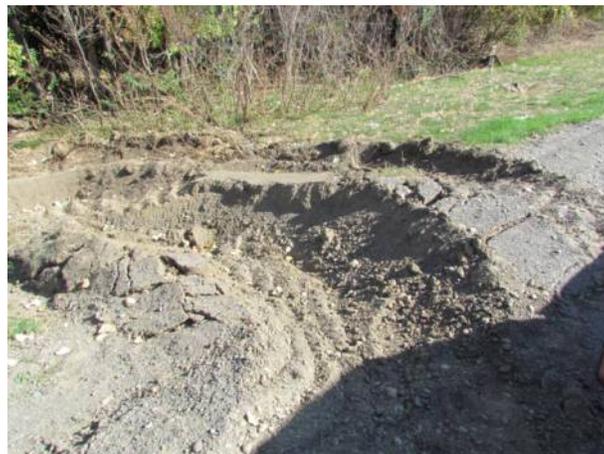
Looking southeast at slope damage on waterward slope.

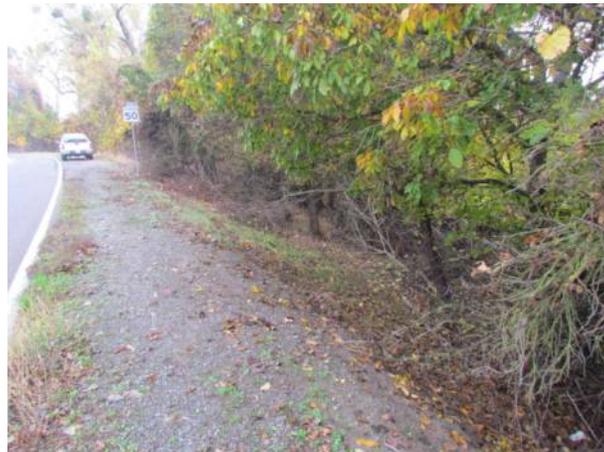
Levee Mile Report Line	52
Start Levee Mile	1.52
End Levee Mile	1.73
Location	Water Side
Category	Earthen Levee
Item	Vegetation
Looking north at dense vegetation on waterside slope.	
richard_f_20130930_733.JPG

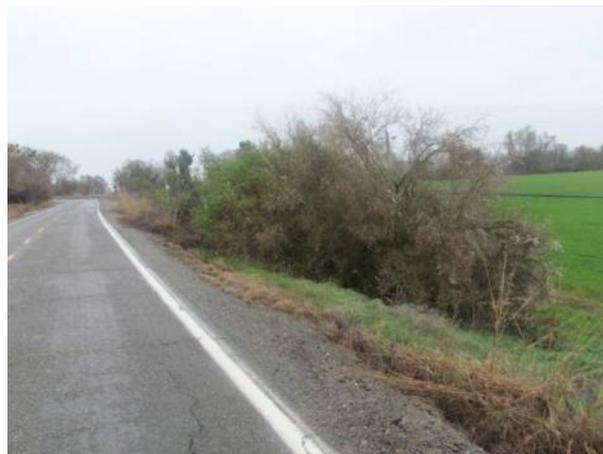
Levee Mile Report Line	53
Start Levee Mile	1.54
End Levee Mile	1.54
Location	Land Side
Category	Earthen Levee
Item	Trim / Thin Trees
Looking south at dense vegetation on landside slope and toe spring 2012.	
richard_f_20130930_758.jpg

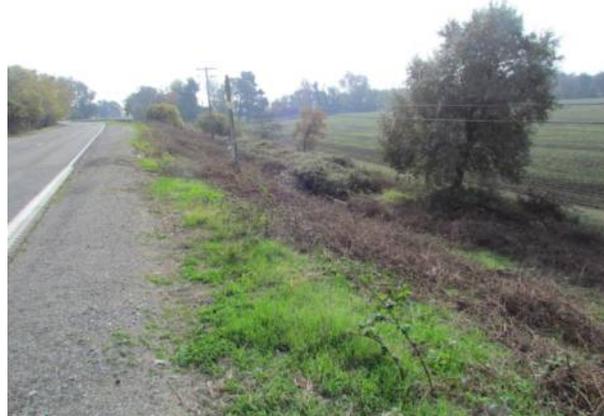
Levee Mile Report Line	53
Start Levee Mile	1.54
End Levee Mile	1.54
Location	Land Side
Category	Earthen Levee
Item	Trim / Thin Trees
Looking southwest at vegetation on landside slope and toe. (Fall Inspection 2012)	
richard_f_20130930_759.JPG

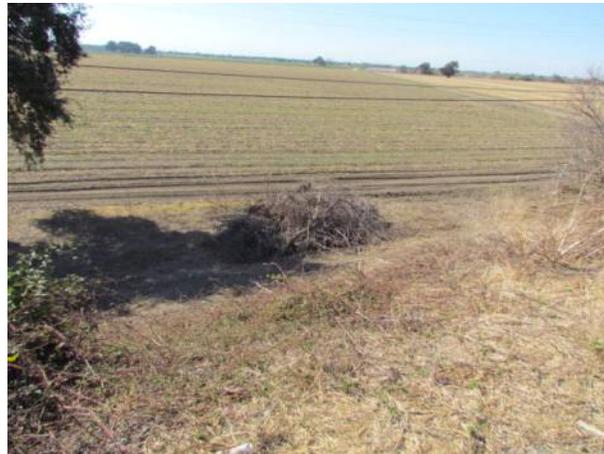
Levee Mile Report Line	55
Start Levee Mile	1.56
End Levee Mile	1.56
Location	Land Side
Category	Earthen Levee
Item	Encroachments
Looking west a prunings on landward berm.	
richard_f_20131024_116.JPG

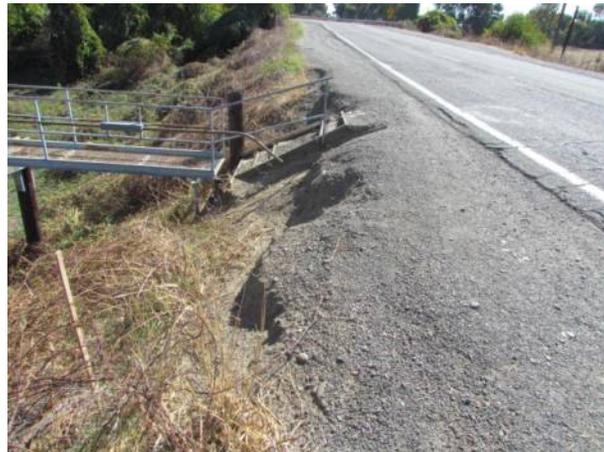
DWR ID: DWR_RD0765_01_f_2013_59										
56	1.56	1.56	Earthen Levee	Erosion / Bank Caving	WS Ma	U	E2 : Schedule repair of erosion site prior to the next inspection. Inspector Comments: Erosion located around metal walkway on waterward shoulder and slope.	38.482414 ° -121.550804 °	38.482414 ° -121.550804 °	8 Y
DWR ID: DWR_RD0765_01_f_2013_8

Levee Mile Report Line	56
Start Levee Mile	1.56
End Levee Mile	1.56
Location	Water Side
Category	Earthen Levee
Item	Erosion / Bank Caving
Looking south at erosion on waterward shoulder.	
richard_f_20131024_110.JPG

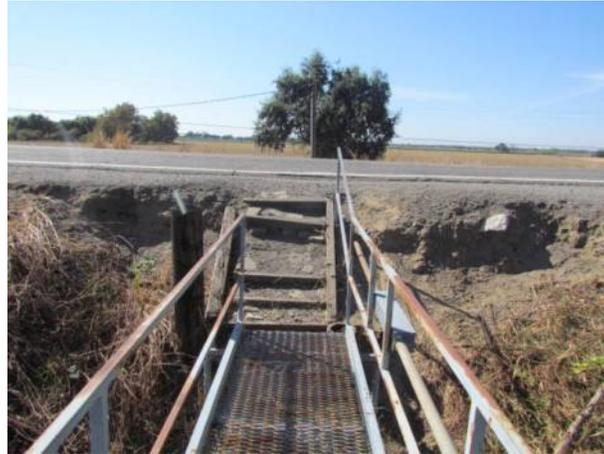
Levee Mile Report Line	56
Start Levee Mile	1.56
End Levee Mile	1.56
Location	Water Side
Category	Earthen Levee
Item	Erosion / Bank Caving
Looking west at erosion on waterward shoulder and slope.	
richard_f_20131024_111.JPG

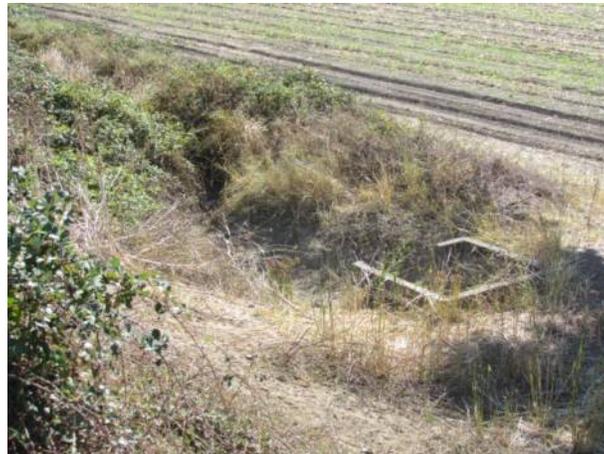
Levee Mile Report Line	57
Start Levee Mile	1.57
End Levee Mile	1.63
Location	Land Side
Category	Earthen Levee
Item	Encroachments
Looking southwest at irrigation ditch on landward toe.	
richard_f_20131024_121.JPG

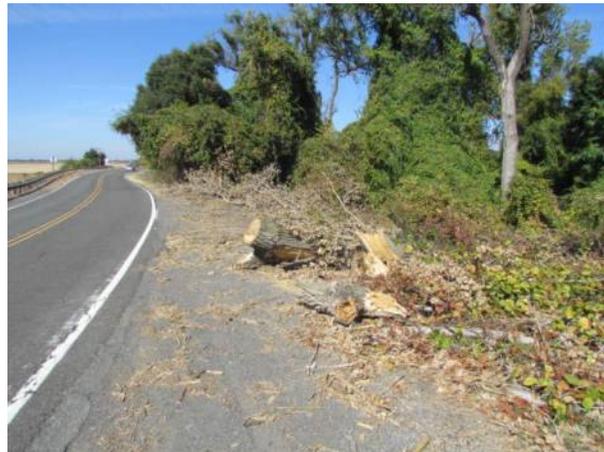
Levee Mile Report Line	60
Start Levee Mile	1.69
End Levee Mile	1.70
Location	Water Side
Category	Earthen Levee
Item	Encroachments
Looking northeast at tree limbs on waterward slope.	
richard_f_20131024_109.JPG

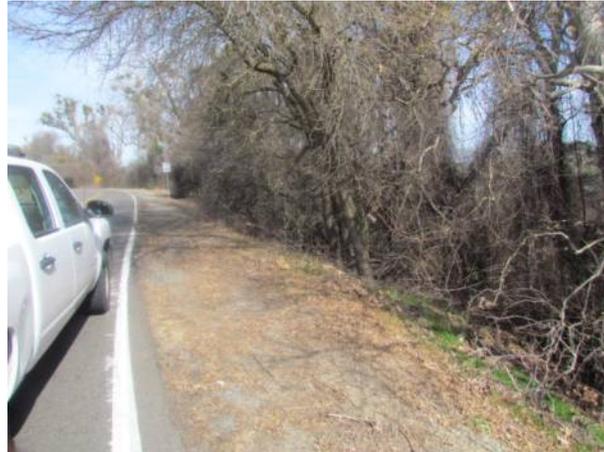
Levee Mile Report Line	61
Start Levee Mile	1.71
End Levee Mile	1.72
Location	Water Side
Category	Earthen Levee
Item	Trim / Thin Trees
Looking north (upstream) at dense trees on landside slope.	
richard_f_20130930_778.JPG
